ASSESSMENT REPORT			
Unique Document ID and Revision No:	ONR-OFD-AR-19-055 Revision 0	TRIM Ref:	2019/273315
Project:	Hartlepool Reactor 2 2019 Periodic Shutdown		
Site:	Hartlepool		
Title:	Hartlepool Reactor 2 2019 Periodic Shutdown: Structural Integrity Assessment of the Graphite Core Inspection Findings		
Nuclear Site Licence No:	59		
Licence Condition(s):	30, 28		
ONR Assessment Rating (Mandatory): <i>(Rating should be based on licensee's original safety case submission)</i>	GREEN		
COIN Service Order:	SVC4285368

**Hartlepool Reactor 2 2019 Periodic Shutdown – Assessment of the results of the  
Graphite Core Inspections**

Assessment Report ONR-OFD-AR-19-055  
Revision 0  
27 SEPTEMBER 2019

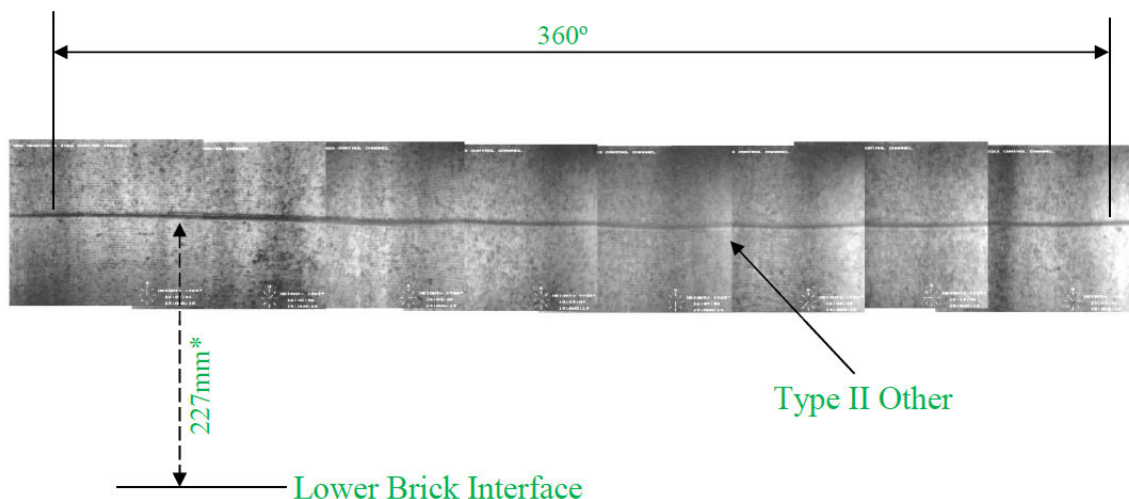
34. During the periodic shutdown, one CR channel (Q22) was visually inspected. During the inspection of Q22 a fully circumferential defect was observed in layer 10 approximately 227mm from the brick interface. Figure 1 shows a montage of the fully circumferential defect observed in Q22.

**Figure 2:** Circumferential defect observed in CR channel Q22 (References 1 and 14).

35. It was my opinion that the quality of the images did not allow for a conclusive opinion to be drawn on to the origin of the defect. It was therefore decided to conduct an additional intervention at the Wood offices in Knutsford. The findings from this intervention are reported in Reference 10.

38. From the video footage I observed, the defect appears to be consistent with other machining marks of limited depth. No crack-like feature appears to be present from the footage. A similar video footage showed that a similar defect taken had been observed in other CR channels, i.e. Layer 15 of 1L14 observed for HRA R1 in 2018 (Reference 11). This defect was classed as a manufacturing defect and had a similar morphology as the defect observed at the current outage. The video footage taken during commissioning indicates that the defect was likely to have been present at the time of construction (Reference 12). Hence, I am content that the defect observed in control rod channel Q22 is likely to have been caused by machining during the manufacture of the brick.

39. It is my opinion that a 360° scan of the defect (as performed for other similar observations) would have improved the sentencing of this defect. However, I consider that the video provides images of sufficient quality for the defect on Q22 to have been adequately sentenced by the GAP.

40. NGL produced Reference 14 which assesses the defect, the condition of the surrounding reactor core and the implications on the existing safety case. The evidence presented in Reference 14 appears to support the judgement that the fully circumferential defect in CR channel Q22 is a machining defect and I have focused my assessment on whether this indication could affect the integrity of the core. I have not taken a view on Reference 13 which argues that the presence of cracks in CR channels is acceptable.

41. In my opinion, the irradiation in CR channels is likely to be too low for any significant driving force to be present at the location of the defect for the machining mark to develop into a crack. There is also no evidence from the inspection videos of any horizontal displacement which could indicate a crack. I therefore conclude that the circumferential defect observed in CR channel Q22 is unlikely to present a challenge to the structural integrity of the core or to result in impediment to CR entry.
