ASSESSMENT REPORT			
Unique Document ID and Revision No:	ONR-OFD-AR-18-027 Revision 0	TRIM Ref:	2018/250001
Project:	Heysham 1 Reactor 2 2018 Periodic Shutdown		
Site:	Heysham 1		
Title:	Heysham 1 Reactor 2 2018 Periodic Shutdown: Structural Integrity Assessment of the Graphite Core Inspection Findings		
Nuclear Site Licence No:	60		
Licence Condition(s):	30		
ONR Assessment Rating (Mandatory): <i>(Rating should be based on licensee's original safety case submission)</i>	GREEN		
COIN Service Order:	SVC4285368

**Heysham 1 Reactor 2 2018 Periodic Shutdown – Assessment of the results of the
Graphite Core Inspections**

Assessment Report ONR-OFD-AR-18-027
Revision 0
AUGUST 2018

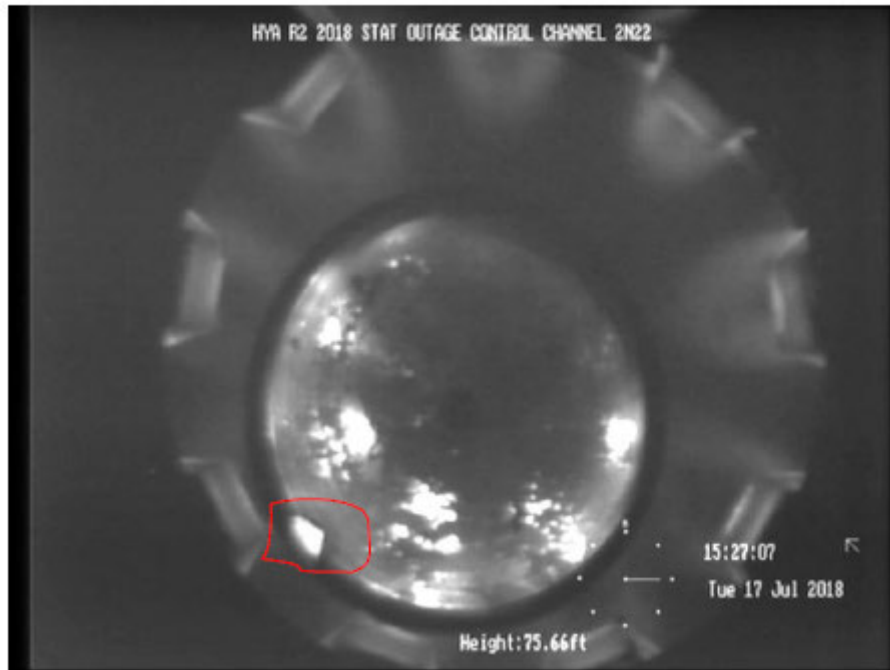
37. Two other cracks were previously observed bore cracks which have either grown or been reclassified (both D15 layer 10). No defect was observed in the control rod channel inspected (N22) although NGL reported the presence of a piece of debris in the debris pot, which is likely to be a metallic compound according to NGL (Reference 17). The piece of debris observed in N22 is shown in Figure 2 below.

Figure 2: Piece of debris observed in debris pot in control rod channel N22.

38. I consider that the piece of debris which is visible in Figure 2 is small and unlikely to be significant (see evidence 1.2.1 of Reference 4). I therefore consider that this finding would not challenge the structural integrity of the core or the safety case and is acceptable.

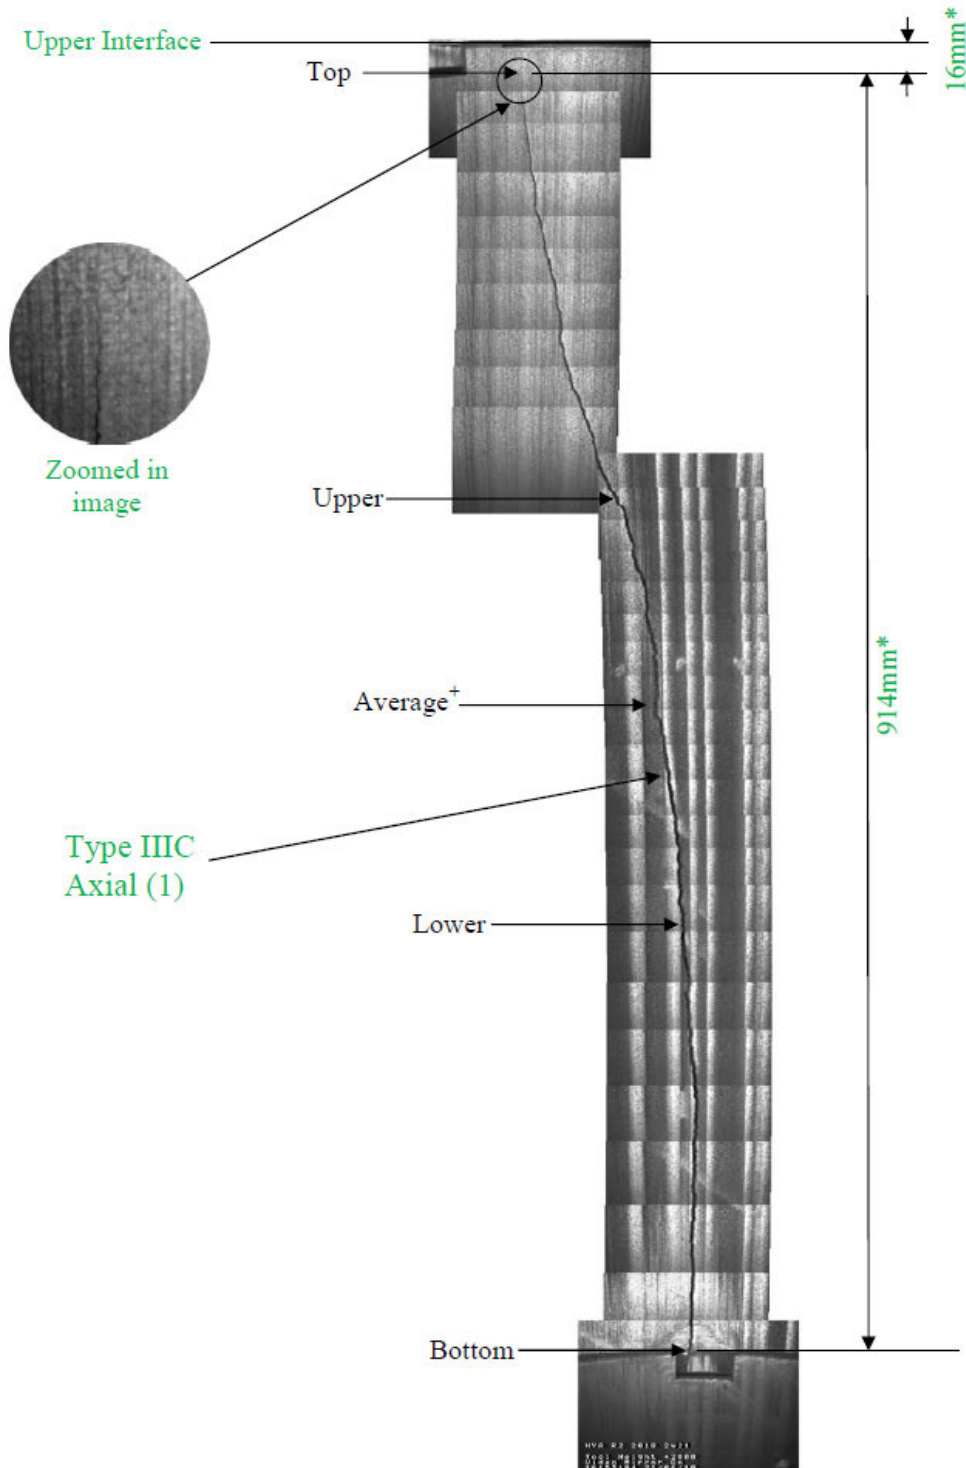
Figure 3: Axial crack observed in Channel W21, Layer 10.

45. As Figure 3 shows, the axial crack observed in Channel W21, Layer 10, seems to originate from the end face key at the interface between layer 9 and layer 10 and follows a generally upward path with a circumferential variation from the 170° position to 120° around the bore of the brick. NGL sentenced this crack as being bore-initiated, which the small 'lipping-in' in the cardioid plot seems to suggest in the GAP sheet (Reference 16). I consider that NGL's sentencing of the crack appears to be appropriate. Although the angle of the crack appears to be unusual, I consider that this observation does not challenge the safety case assumptions and can be categorised as an axial crack.

46. Stress reversal in irradiated graphite occurs after a period of time when the dimensions of the graphite stop shrinking and begin to expand and is thus a precursor to keyway root cracking. Evidence of the onset of stress reversal would represent a challenge to the current safety case as it would undermine the safety case prediction of the date of onset. Of the channels that had been inspected at previous periodic shutdowns, none had previously contained a full axial crack, therefore no direct evidence of crack opening due to stress reversal is available. I have reviewed the inspections findings and find that the characteristics of pre-stress reversal behaviour are present, such as lipping-in of the crack at the bore surface and therefore consider that NGL' sentencing of the cracks as bore cracks appear to be reasonable.

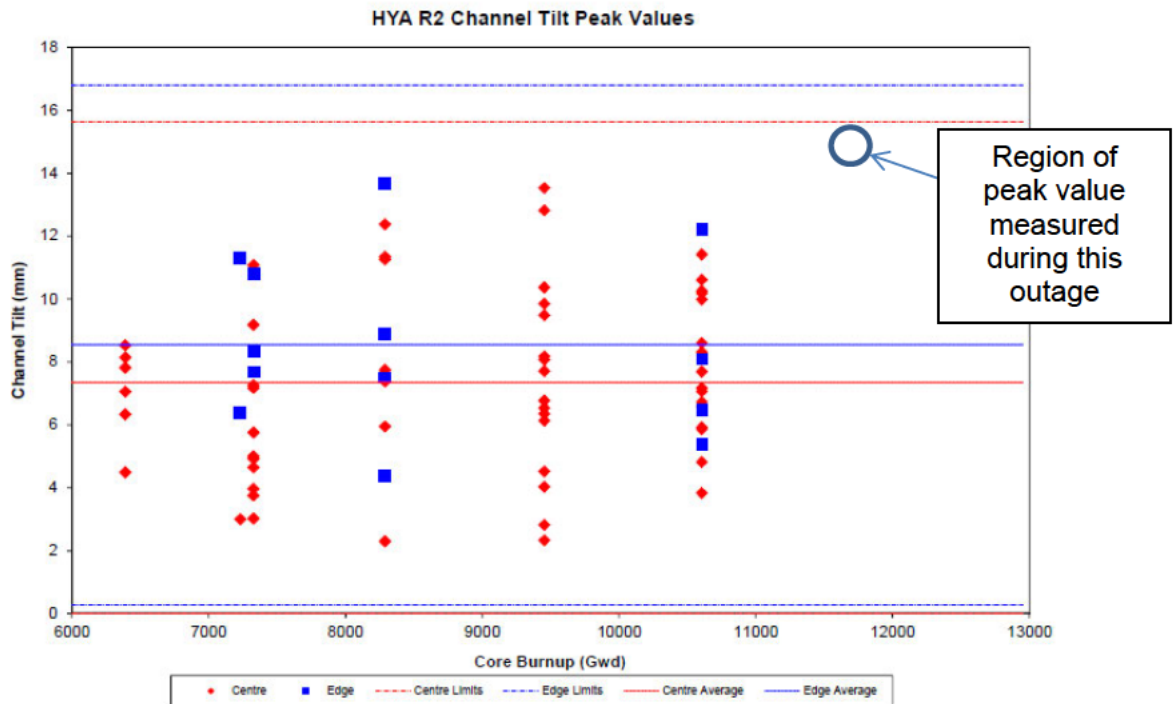
50. The channel tilt measured in Channel W21, an edge channel (Figure 1), is 15.3mm in layer 11 and 15.2mm in layer 12 (evidence 1.4.1 of Reference 4). This is the highest channel tilt yet measured at HYA and amongst the highest in the fleet (Table 5 of Reference 14). Channel W21 has no previous inspection history. NGL's view in EC 363869 is that the channel tilt measured in Channel W21 is not significant compared to the channel length of 10 meters and considered the measurements to be within expectation. NGL also considered the channel bow to be relatively small (4.2mm maximum at layer 7), which indicates that keyway disengagement is therefore unlikely to have occurred in the vicinity of the channel. Figure 4 shows the historical channel tilt measurements at HYA 2 (from Reference 14). I added a circle to this graph to show the approximate region of the maximum channel tilt measured during the current periodic shutdown for reference, i.e. 15.3mm.

Figure 4: Historical channel tilt measurements at HYA R2.

51. Figure 4 shows that the latest channel tilt measurement of Channel W21 seems to be quite significant compared to similar historical measurements, although not outside expectations. Furthermore, higher channel tilts were measured at HRA. I also note that there is currently no safety case limit being applied to the maximum channel tilt value. I therefore consider that the maximum channel tilt value of 15.3mm measured for Channel W21 is unlikely to challenge the structural integrity of the core.
52. Overall, the measurements from the graphite core inspections appear to be within expectations and do not seem to challenge the assumptions of the safety case.
