EDF Energy Nuclear Generation Ltd

Decommissioning of Hinkley Point B Nuclear Power Station

Environmental Statement

Volume III: Appendices - Part 2

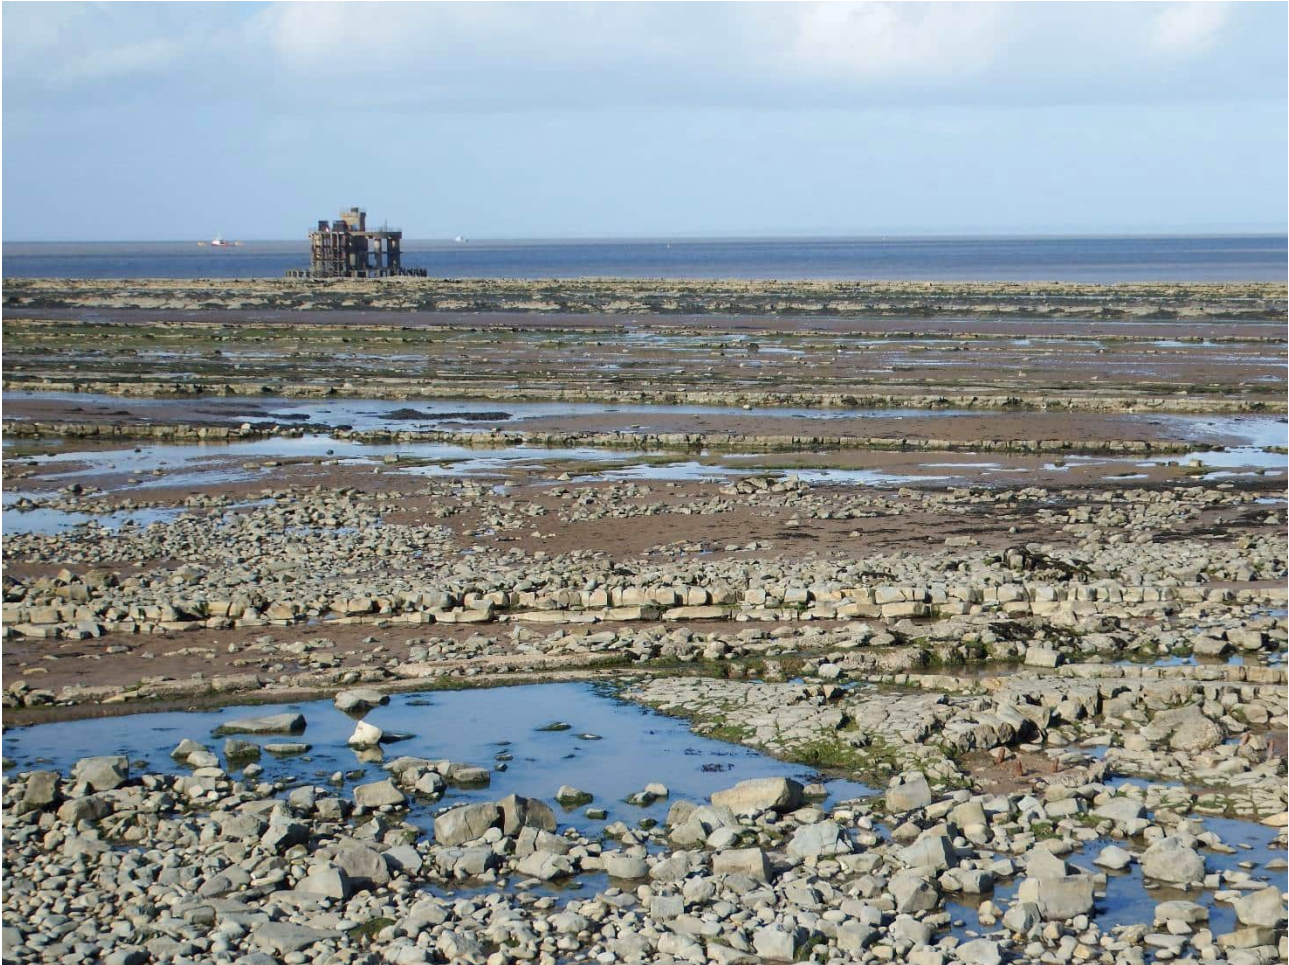
Photo 3.1 View down the shore showing sequence of limestone steps and slopes, some ending in broad channels

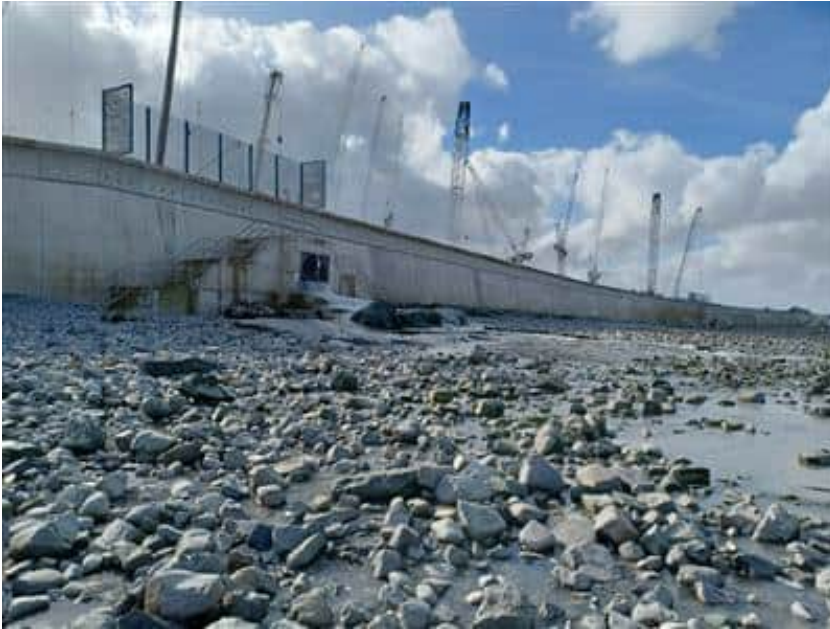
Photo 3.2 Biotope LS.LCS.Sh.BarSh on upper shore

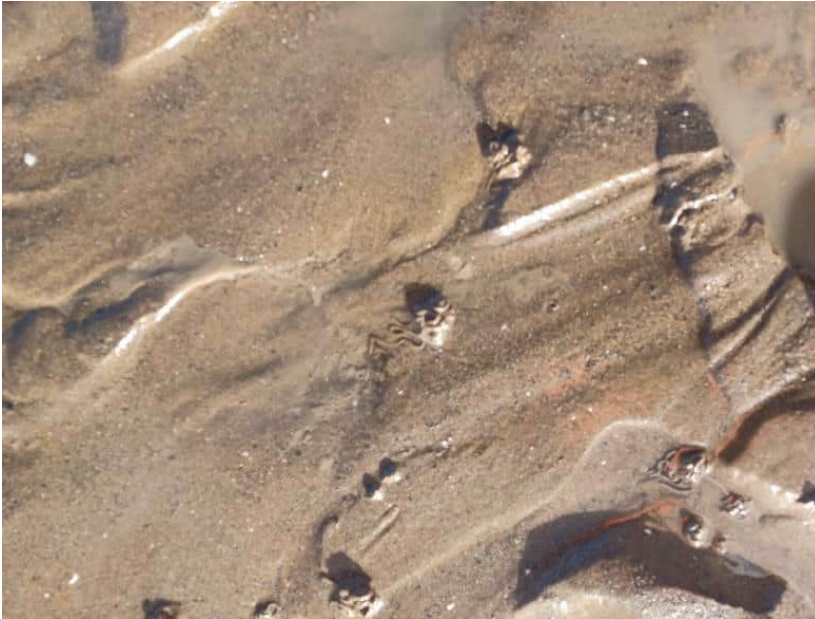
Photo 3.3 Biotope LS.LSa.MuSa.MacAre with lugworm casts and rippled surface on the upper shore

- 3.2.4 There were extensive areas of fine sand and muddy sand, with scattered stone, boulders and cobbles. Large areas of this biotope were found towards the eastern boundary of the survey area on the upper shore and additionally, there was a small area of this biotope close to the cooling water outlet channel. The biotope was also found near the western boundary on the upper shore as well as further down the shore towards the sea in the larger channels. Areas near the western boundary with this biotope present, often had rippled surfaces.

- 3.2.5 This biotope is subject to variable salinity conditions and was characterised by the casts of the lugworm *Arenicola marina*, which were visible on the sediment surface. The areas with this biotope on the upper shores had scattered boulders and rocks with attached fucoids.

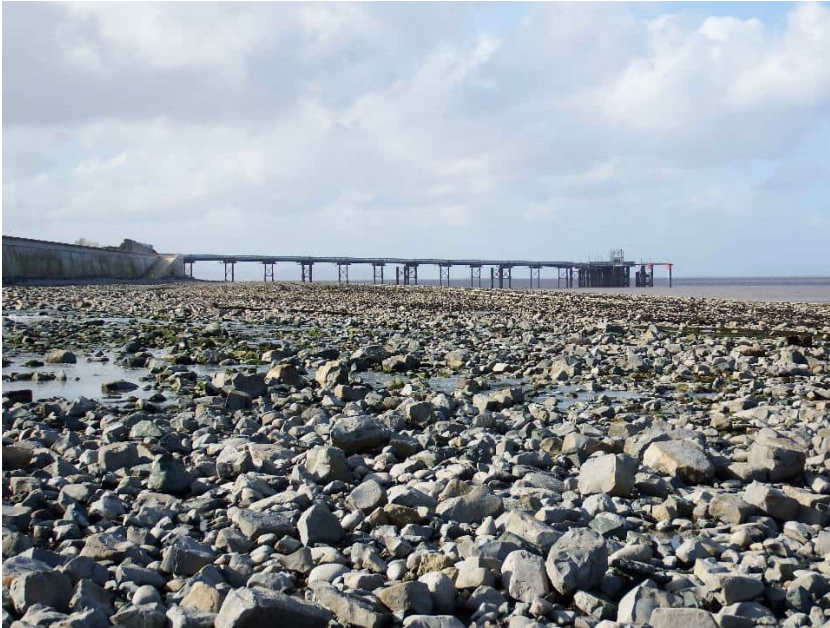
Photo 3.4 Biotope LS.LMx.Mx on the upper shore

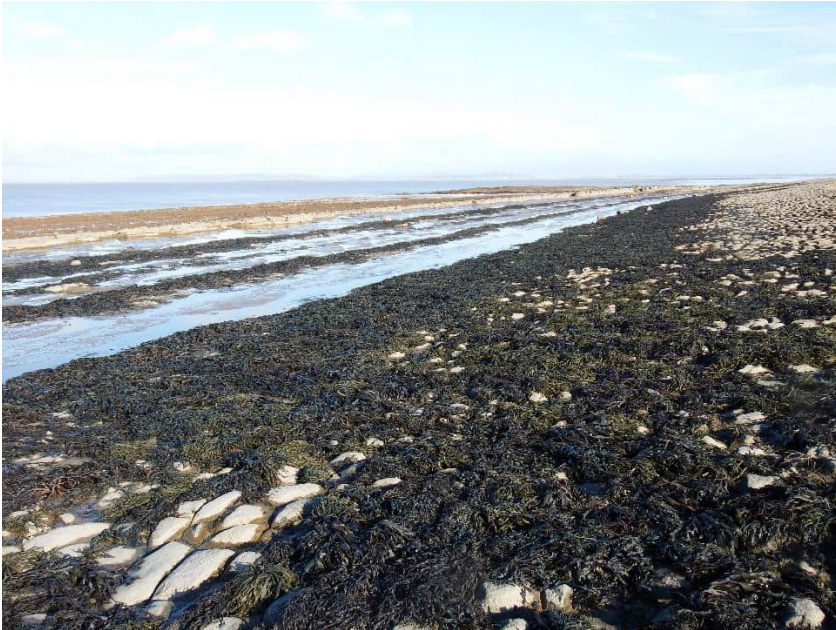
Photo 3.5 Biotope LR.LLR.FVS.AscVS on the mid shore

- 3.2.9 This biotope was found across the survey area between the eastern and western boundaries and from the upper shore to the lower shore. The habitat validation survey recorded an area of sheltered (low energy) biotope comprising fucoids (*Fucus* spp and *Ascophyllum nodosum*) on boulder and cobble habitat, with a limited understorey of green algae of the Ulvaceae, corresponding to the biotope **LR.LLR.FVS.AscVS** (see **Photo 3.6**).

- 3.2.10 This biotope was often observed on top of the limestone layers lower down the slope, which due to the sloping nature of the blocks, provides a sheltered environment allowing for extensive macroalgae cover. Both species of wracks (*Ascophyllum nodosum* and *Fucus vesiculosus*) has a lot of air bladders further indication of a sheltered environment.

- 3.2.11 The presence and extent of this biotope during the habitat validation survey corresponded very closely to its presence recorded in the 2020 Phase 1 habitat survey, with no indication of any significant change

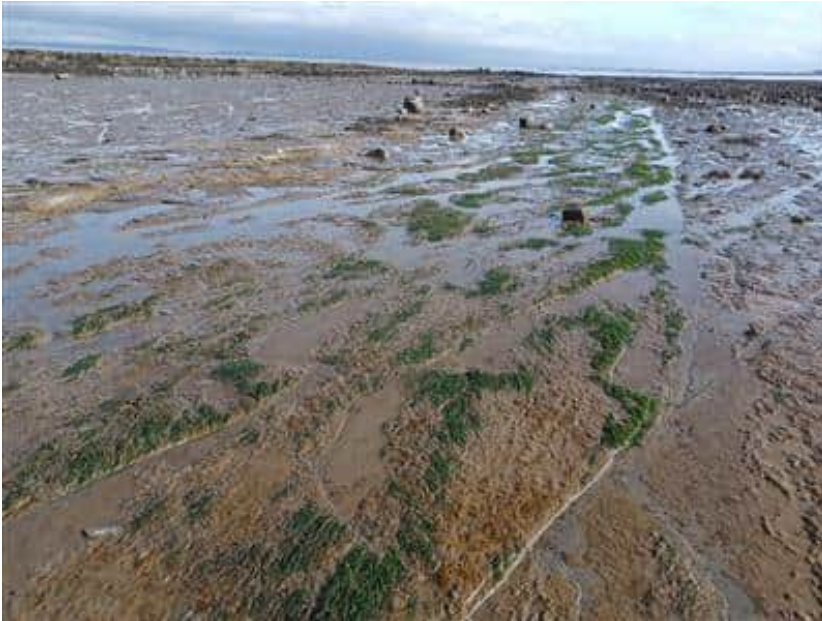
Photo 3.6 Biotope LR.FLR.Eph.EphX observed in one of the lower shore channels

- 3.2.13 The observations during the habitat validation survey were broadly consistent with the presence and extent of this biotope recorded during the 2020 Phase 1 habitat survey, indicating no significant change. Some areas in the previous survey were classified as **LR.LLR.FVS.FvesVS**, however, the habitats observed in the habitat validation survey resembled the **LR.FLR.Eph.EphX**. This change in biotopes is probably a result of seasonal change and the general dynamic nature of this area of the coast. The channels allow for more water to be retained and therefore species associated with the **LR.FLR.Eph.EphX** biotope are more likely to thrive.

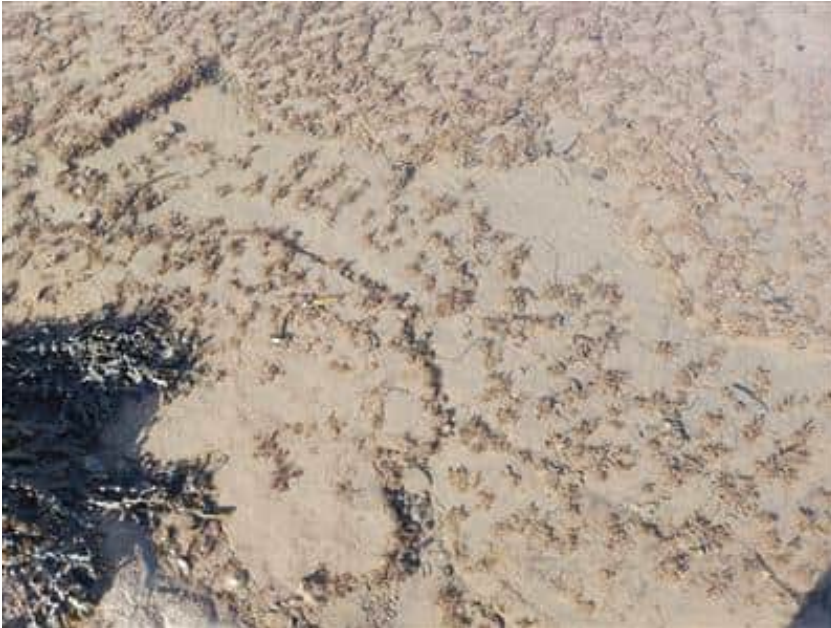
Photo 3.7 Biotope LR.FLR.Rkp.Cor.Cor observed in rockpools

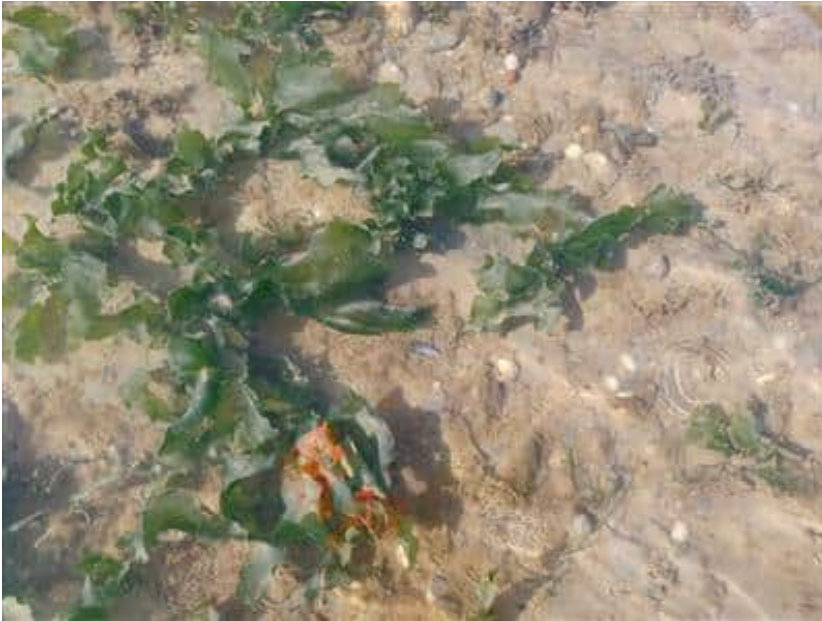
Photo 3.8 Biotope LR.FLR.Rkp.SwSed observed in sediment floored rockpools

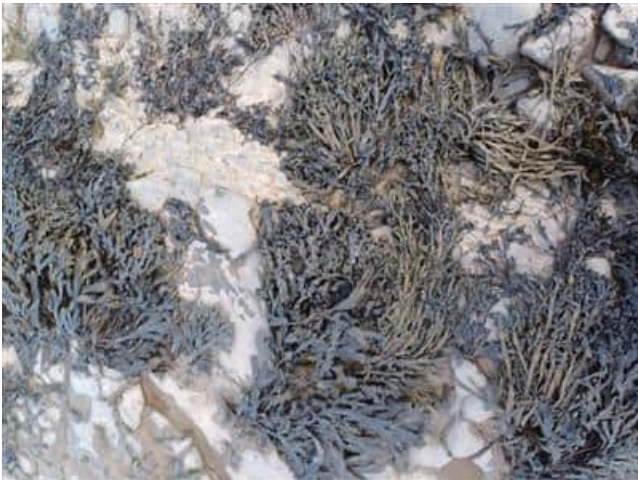
Photo 3.9 Biotope LR.MLR.BF.Fser.Bo on mid shore

- 3.2.21 On this basis, there is no evidence of significant change in these areas since the 2020 Phase 1 habitat survey.

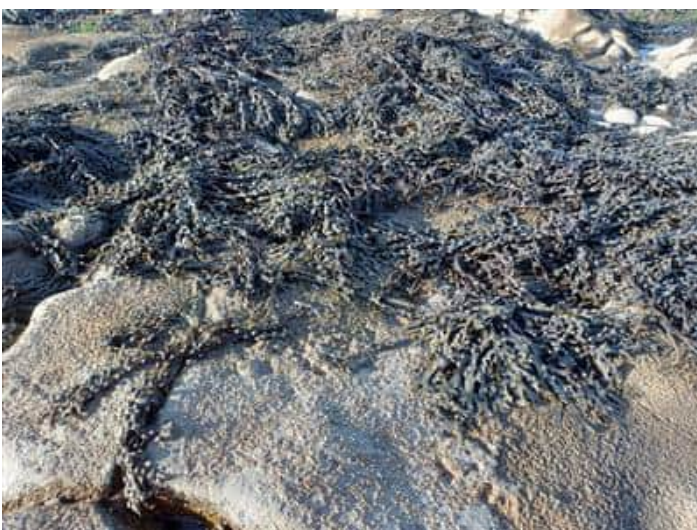
Photo 3.10 Biotope LR.LLR.FVS.FvesVS on mid shore

- 3.2.22 The western and eastern survey area boundaries in the mid and upper shore, have layers of sheltered to extremely sheltered shoreline, which supports the growth of *Fucus vesiculosus*. This biotope has variable salinity and the barnacle *Semibalanus balanoides* was also present.
- 3.2.23 Due to a higher tidal level, this biotope was not distinguished in the 2020 Phase 1 habitat survey from the **LR.LLR.FVS.AscV** biotope which also typically has furoid species present. The greater visibility during the habitat validation survey enabled identification of the presence of the **LR.LLR.FVS.FvesVS** littoral biotope, which occurred in the same locations where the presence of **LR.LLR.FVS.AscV** was recorded in the 2020 Phase 1 habitat survey.
- 3.2.24 On this basis, there is no evidence of significant change in these areas since the 2020 Phase 1 habitat survey.

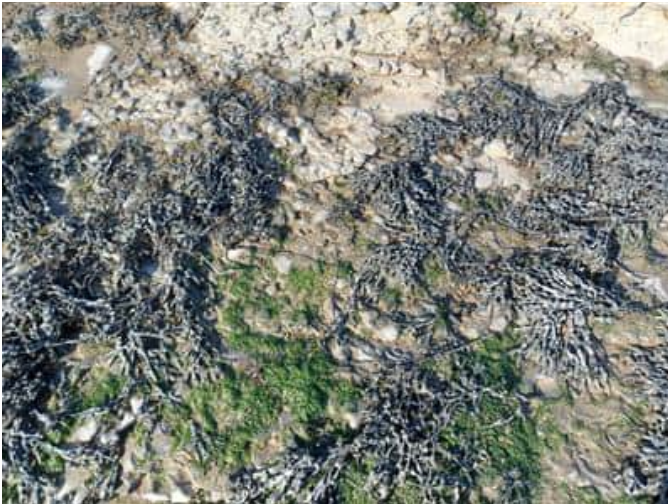
Photo 3.11 Biotope LR.MLR.BF.FvesB on mid shore

- 3.2.25 The western survey area boundary in the mid shore to upper shore had areas of exposed to moderately exposed (moderate energy) shoreline with areas of mid eulittoral boulders and bedrock supporting fucoids (mainly *Fucus vesiculosus*) and the barnacle *Semibalanus balanoides*. Other invertebrates recorded included the limpet *Patella vulgate*.
- 3.2.26 Due to a higher tidal level, this biotope was not distinguished to a level 5 biotope classification, in the 2020 Phase 1 habitat survey. The greater visibility during the habitat validation survey enabled identification of the presence of the **LR.MLR.BF.FvesB** littoral biotope, which occurred in the same locations, where the presence of **LR.MLR** was recorded in the 2020 Phase 1 habitat survey.
- 3.2.27 On this basis, there is no evidence of significant change in these areas since the 2020 Phase 1 habitat survey.

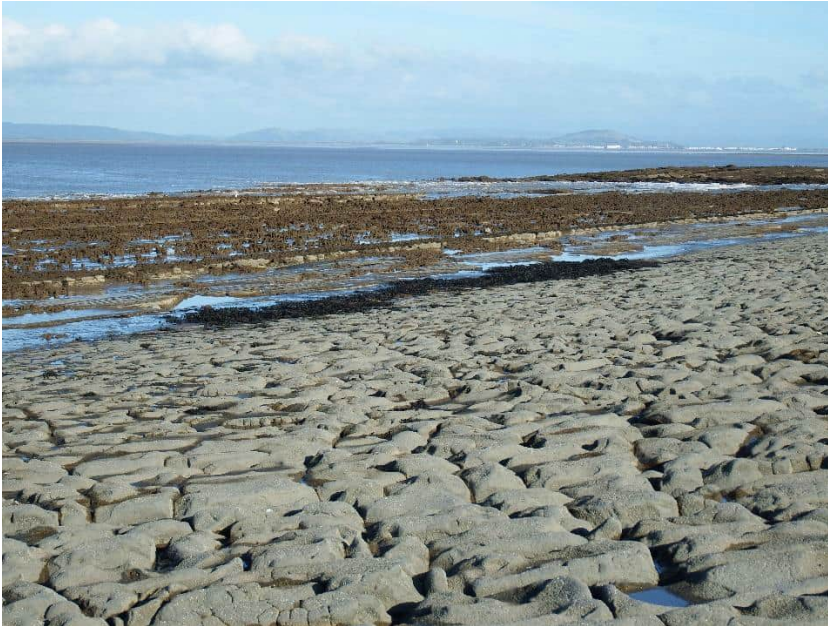
Photo 3.12 Biotope LR.HLR.MusB.Sem.Sem on the lower shore

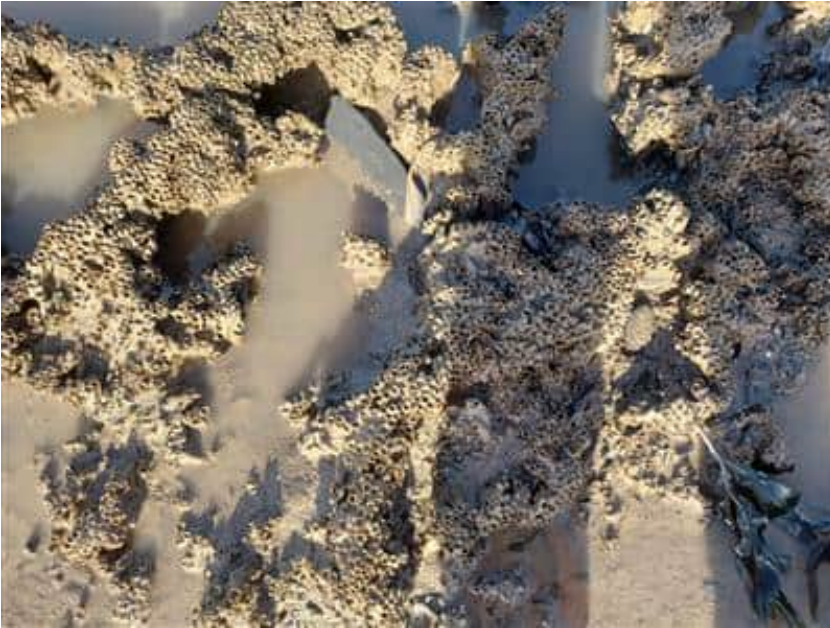
- 3.2.31 In the lower shore environment across the survey area *Sabellaria alveolata* reefs were present. This biotope was found in the exposed environment at the end of the limestone block layers.
- 3.2.32 Lower tidal levels available during the habitat validation survey revealed a large area of littoral sediment and further inspection showed it to be colonised by *Sabellaria alveolata* rather than littoral mud. This reclassification as part of the intertidal zone does not indicate any likely significant change in this polychaete dominated area since the 2020 Phase 1 habitat survey.
- 3.2.33 On this basis, there is no evidence of significant change in these areas since the 2020 Phase 1 habitat survey.

Photo 3.13 Biotope LS.LBR.Sab.Salv in the lower shore

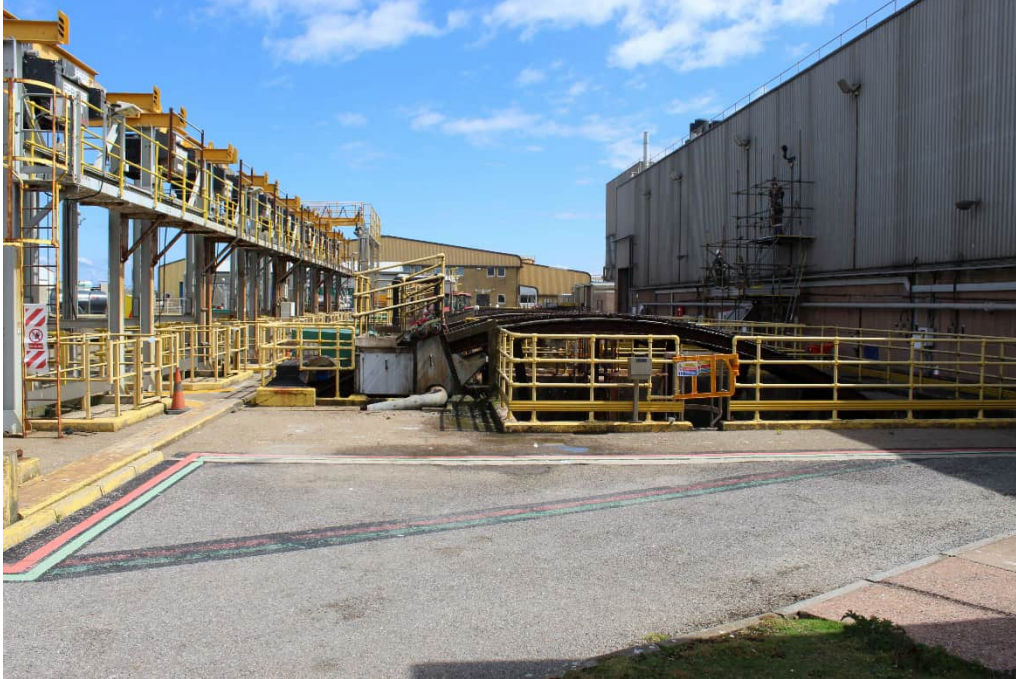
Plate 13. Pumphouse in the northern site area. View east.

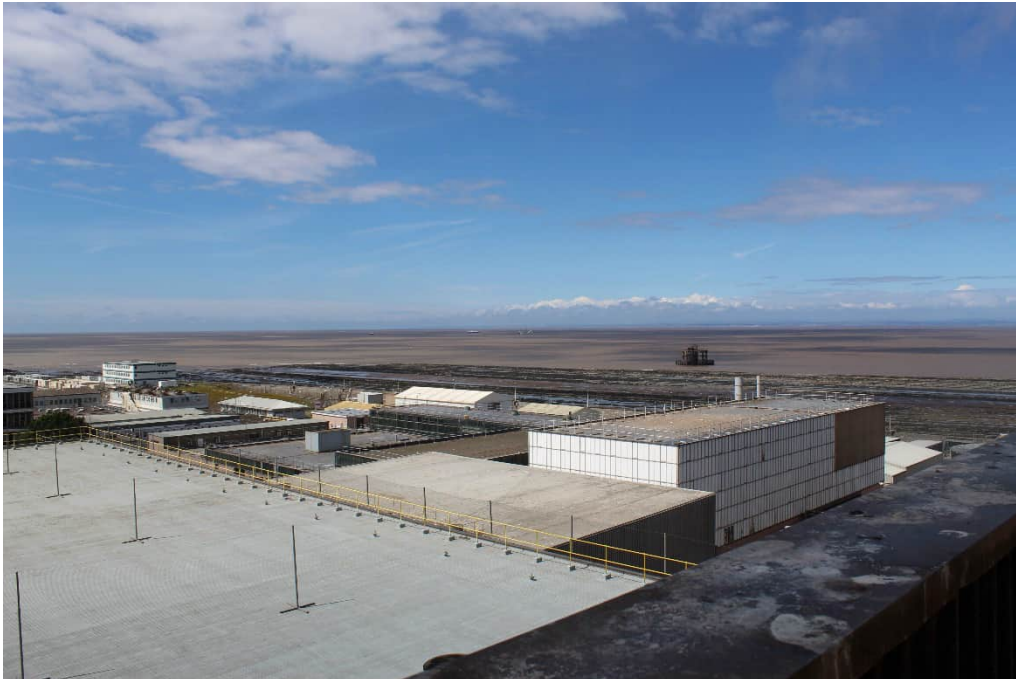
Plate 14. Water intake out to sea to the north. View north-east.

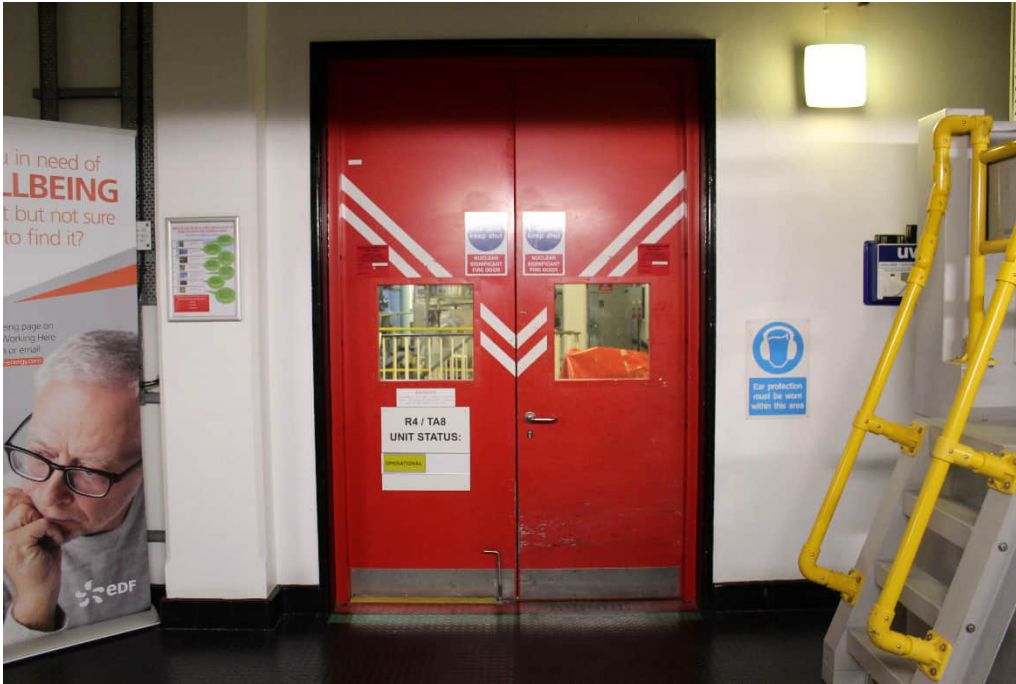
The interior of the reactor buildings and turbine hall included original fixtures (**Plates 15-19**).

Plate 15. Interior entrance to Reactor 4 Unit.

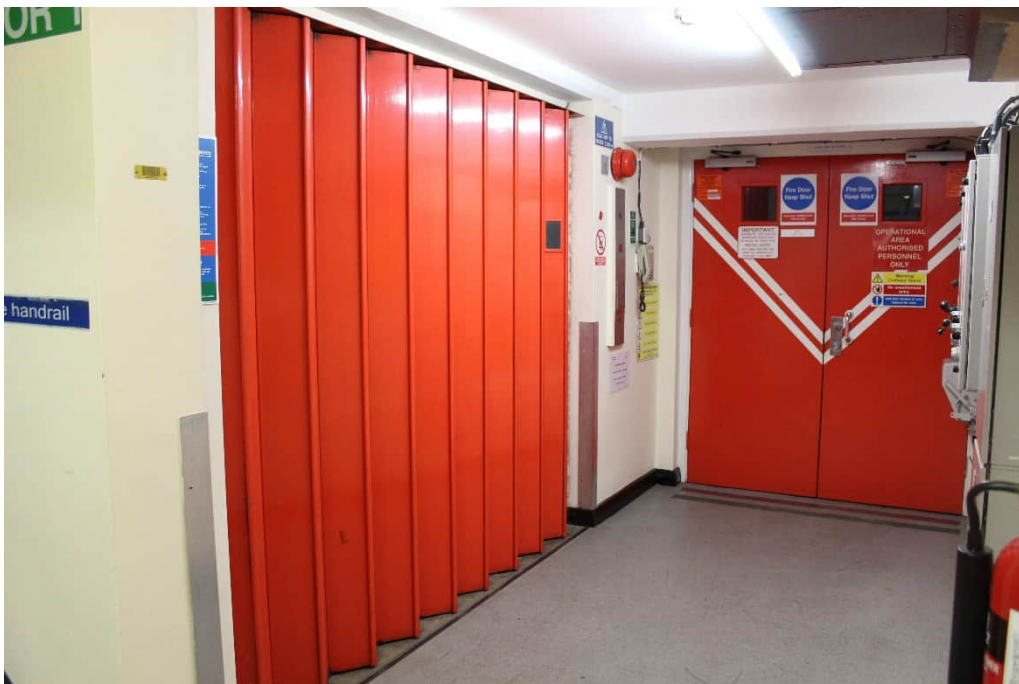
Plate 18. Reactor building interior features.

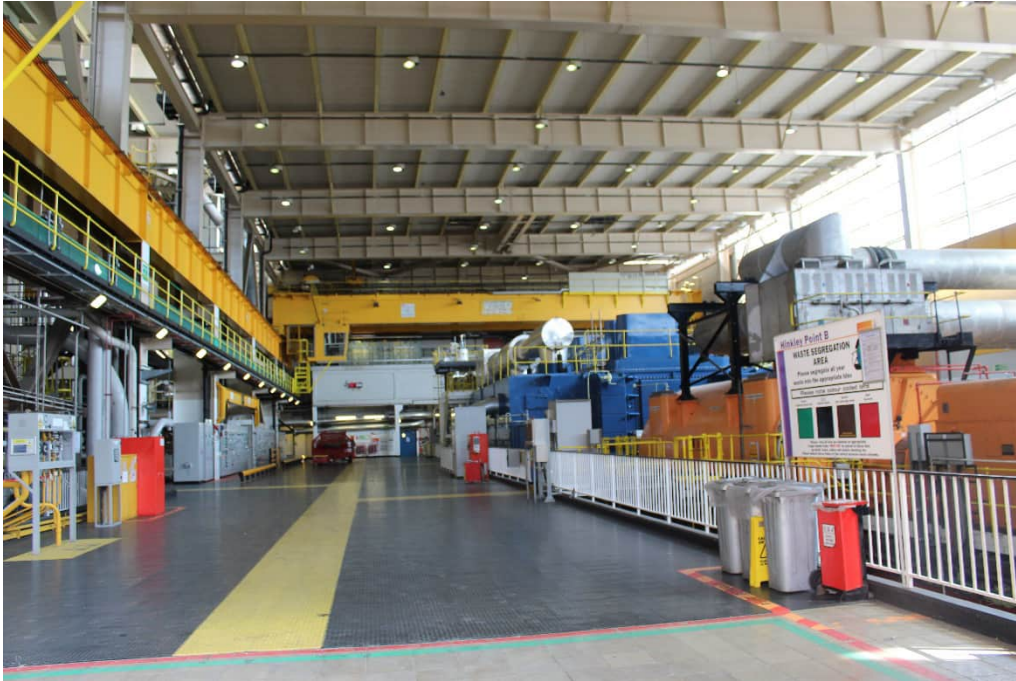
Plate 19. Turbine hall interior.

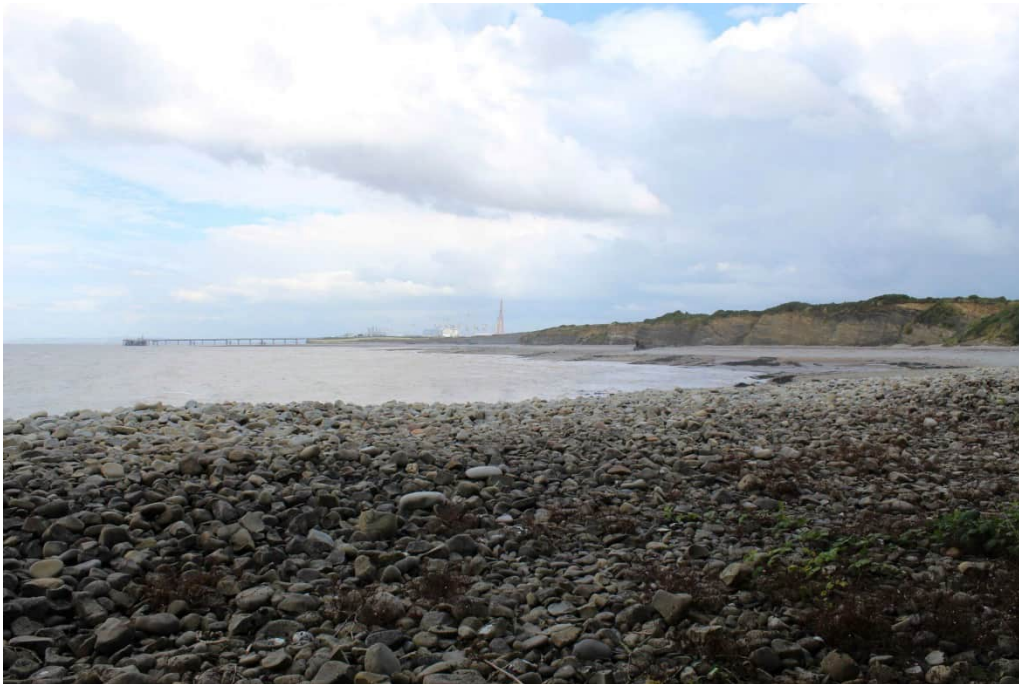
Plate 26. Grade II listed Limekiln Complex (NHLE 1057382), view from the adjacent seashore towards Hinkley Point B. View east.

Mid-19th century limekiln complex on the seashore, in poor condition and overgrown. Comprises part of the 19th century port of Lilstock. The limekiln complex was heavily overgrown and vegetation obscured direct views to Hinkley Point B, which was not readily discernible in most views of or from the asset. However, there were direct long-distanced views from the adjacent seashore (**Plate 26**).
