ASSESSMENT REPORT			
Unique Document ID and Revision No:	ONR-OFD-AR-18-027 Revision 0	TRIM Ref:	2018/250001
Project:	Heysham 1 Reactor 2 2018 Periodic Shutdown		
Site:	Heysham 1		
Title:	Heysham 1 Reactor 2 2018 Periodic Shutdown: Structural Integrity Assessment of the Graphite Core Inspection Findings		
Nuclear Site Licence No:	60		
Licence Condition(s):	30		
ONR Assessment Rating (Mandatory): <i>(Rating should be based on licensee's original safety case submission)</i>	GREEN		
COIN Service Order:	SVC4285368

**Heysham 1 Reactor 2 2018 Periodic Shutdown – Assessment of the results of the
Graphite Core Inspections**

Assessment Report ONR-OFD-AR-18-027
Revision 0
AUGUST 2018

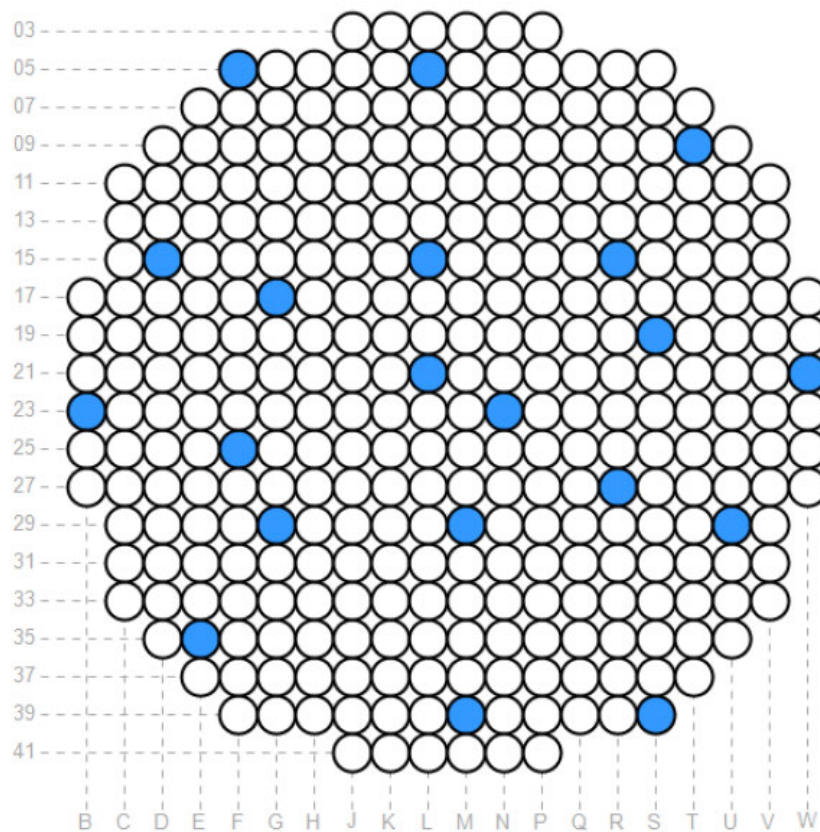
Figure 1: Core map showing the fuel channels inspected during 2018 HYA R2 periodic shutdown.

30. According to the third GAP minutes in Reference 16, twenty fuel channels were selected for inspection, which is one more than stated in the outage intentions document in Reference 15. The channels selected for inspection are shown in Figure 1.
