**Agreement to NP/SC 7810 - Graphite Core: Safety Case for Operation After the
Onset of Keyway root Cracking**

Heysham 2 and Torness Power Stations

Project Assessment Report

Project Assessment Report ONR-OFD-PAR-22-004
Revision 1
June 2022

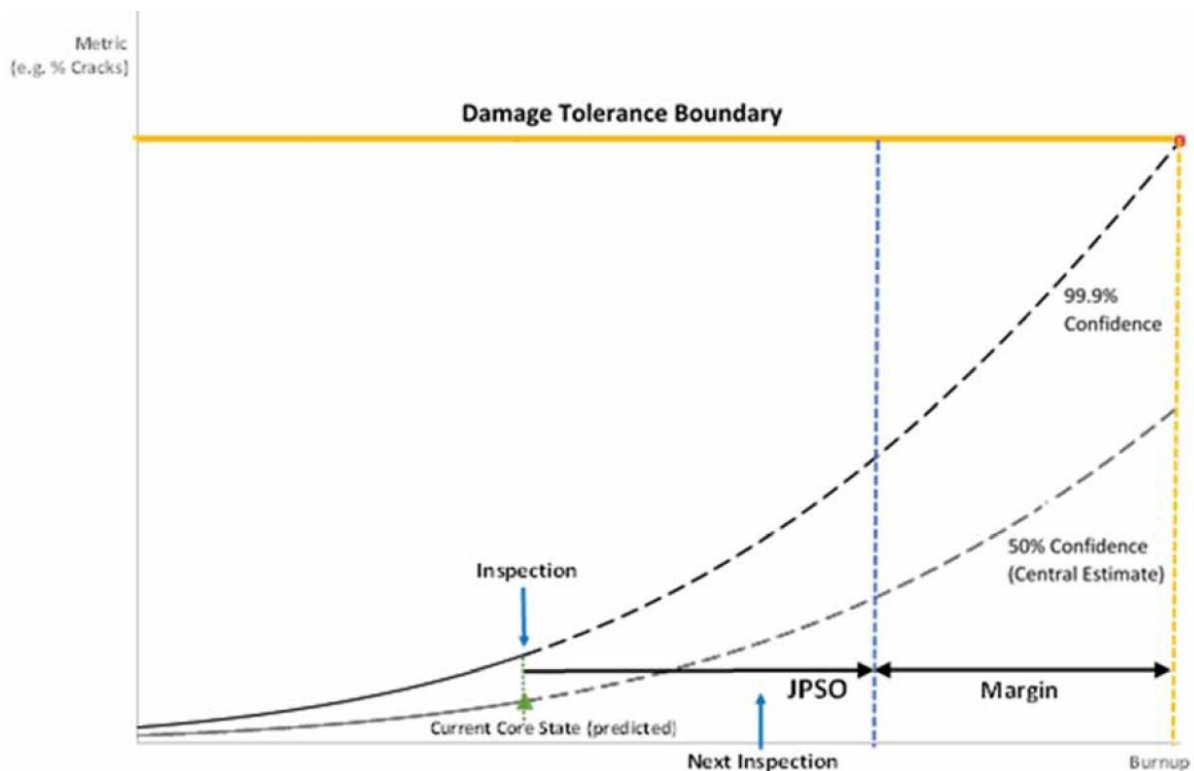
Figure 4. Illustration of Justified Period of Safe Operation, Margin and Damage Tolerance Boundary (Ref. 2).

53. The concept of defining a JPSO with a margin to a DTB is illustrated in **Figure 4**.
54. At 16.5 TWd, the licensee anticipates at a high calculational confidence level of 99.9% that ~ 43% - 45% of the graphite bricks of fuel channels will crack in the central core (layers 3 to 8 and rings 1 to 9). This has been generated through a methodology known as CrackSim. This method has been used extensively for HPB/HNB and HYB/TOR and has been reviewed by ONR previously.

56. The specialist inspector takes confidence from the available margins demonstrated by the licensee between the core state of ~45% cracking expected at a core burn-up of 16.5 TWd and the DTB of 100% cracking. The specialist inspector considers this margin to be adequate based on the expectation that the licensee will monitor the core states against the assumptions used to generate the DTB. ONR will have visibility of the future inspection observations through routine regulatory interactions and any challenge to the margin afforded by the DTB will be discussed at these interactions and justified by EDF NGL if necessary.
